## **UPPER MISSISSIPPI RIVER SYSTEM**

### **DEFINITE PROJECT REPORT/ ENVIRONMENTAL ASSESSMENT (SP-23)**

## **AMBROUGH SLOUGH HABITAT REHABILITATION AND ENHANCEMENT PROJECT**

Pool 10  
Upper Mississippi River  
Crawford County, Wisconsin

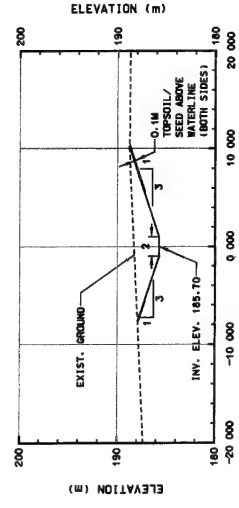
**SECTION 1**  
CHANNEL - GREMARE LAKE  
SCALE: NONE

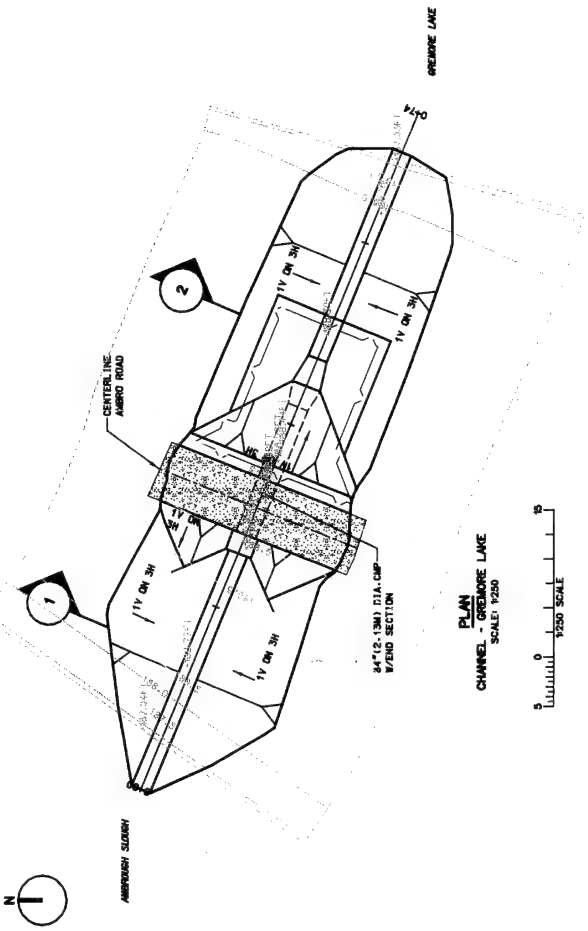
**PLAN**  
CHANNEL - GREMARE LAKE  
SCALE: 1/250

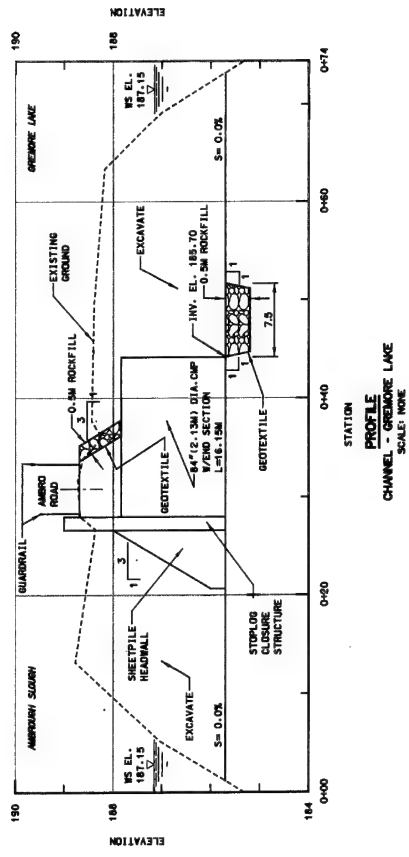
**PROFILE**  
CHANNEL - GREMARE LAKE  
SCALE: NONE
